Earthquake Repairs at Christchurch WWTP – Clarifying the Situation

Greg OFFER, Ian BILLINGS, Tim SCOTT, New Zealand

Key words: Secondary Clarifiers, Earthquake Repairs, Resilience, CIPP Liners

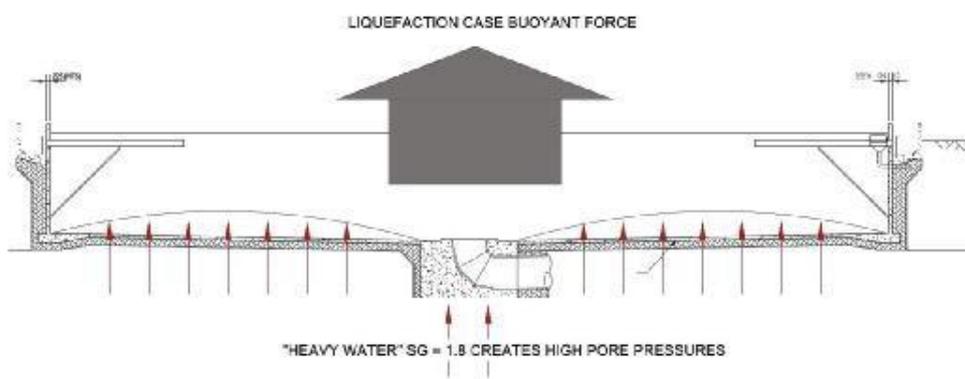
Figure 3: Liquefaction Effects on Clarifier

Damage was caused by ground shaking as well as liquefaction effects. As the soil liquefied the clarifier bases were subjected to liquefaction induced uplift forces: static buoyancy force due to hydrostatic pressure, dynamic uplift force due to excess pore pressure and a seepage force resulting from uplift pressures acting on the soil block below. Figure 3 shows how the uplift pressures imposed forces on the clarifier structures, causing deformation of the floors and causing the entire structure to try to float out of the ground.

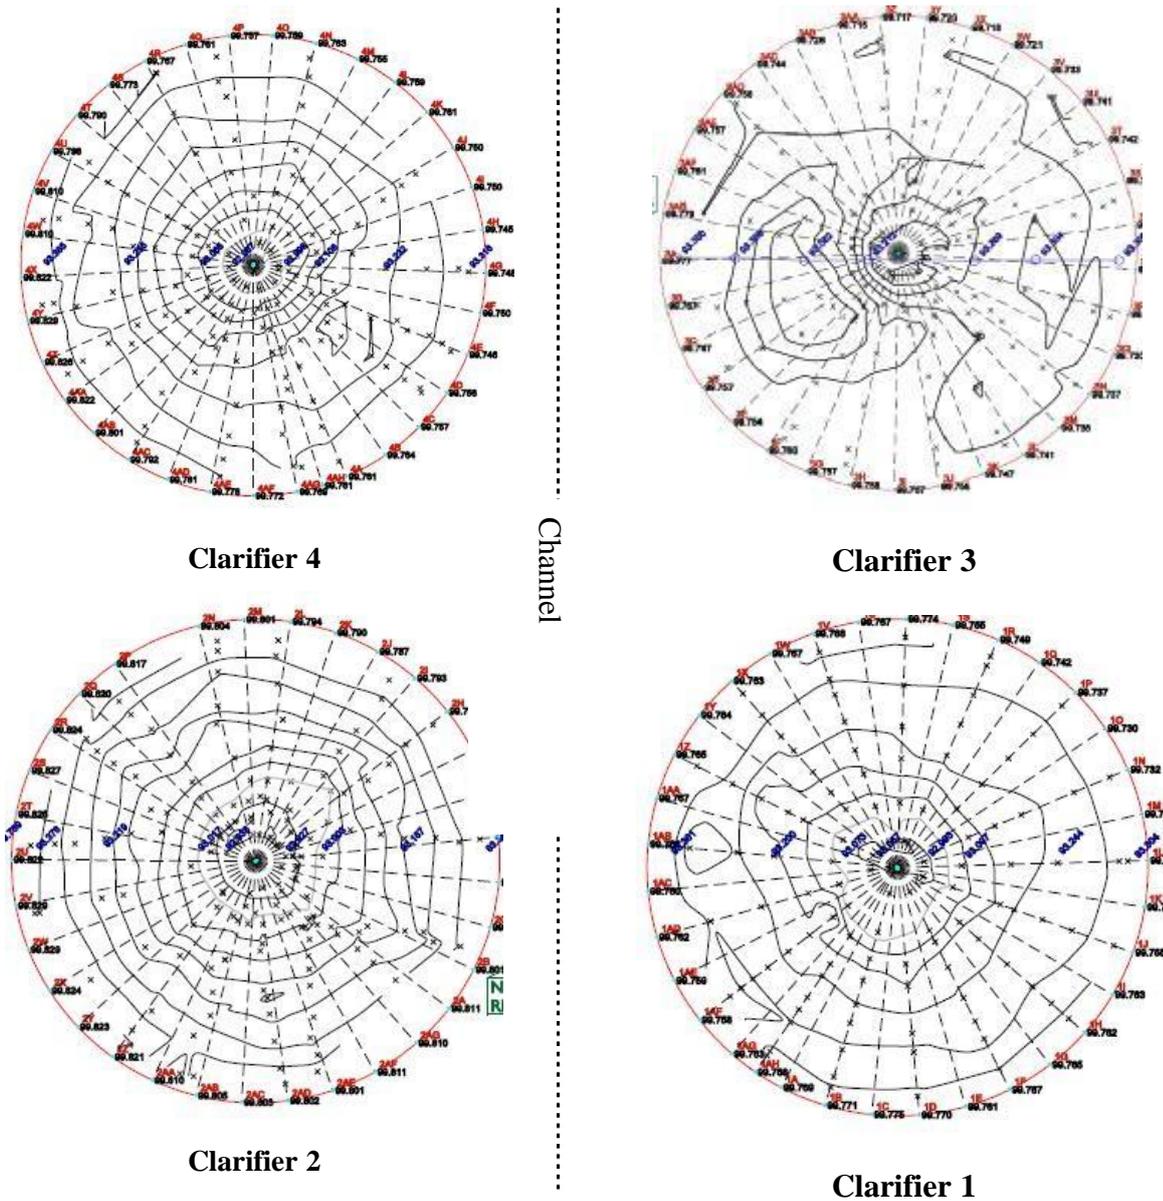
Figure 4: Bathymetric Survey of Clarifier Floors

The bathymetric survey showed that the floors of Clarifiers 2 and 4 appear to be relatively less damaged, with the original floor falls remaining largely intact. The floors on Clarifiers 1 and 3 showed significant deformation, with Clarifier 3 clearly the worst case. This was consistent with observations of the bridge across the centre of the Clarifiers 1 and 3. Based on these results the decision was taken to select Clarifiers 2 and 4 as the first units to be repaired with the objective that they would be fixed and brought back online fairly quickly.

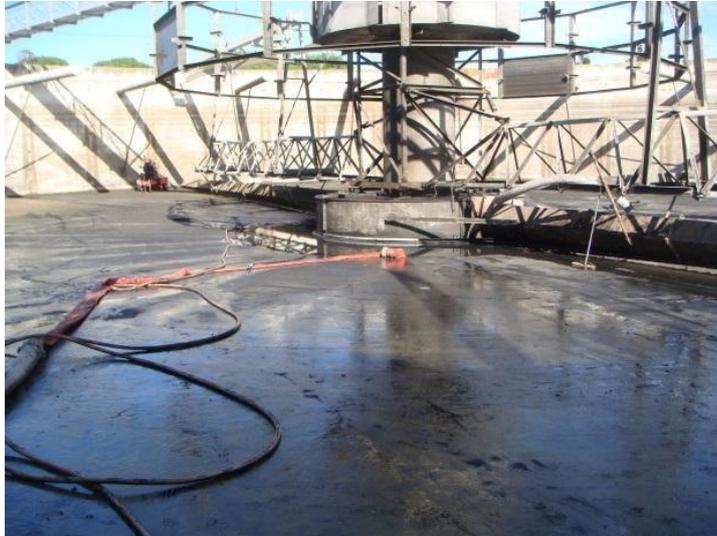
Figure 5: Clean Out of Clarifier 2

Well pointing was installed on Clarifiers 2 and 4 and operated for the 6 weeks necessary to lower the groundwater to a level where the clarifiers could be pumped out. Water and residual sludge was then removed from Clarifier 2 and the internals inspected. Final clean out of clarifier 2 is shown in Figure 5.

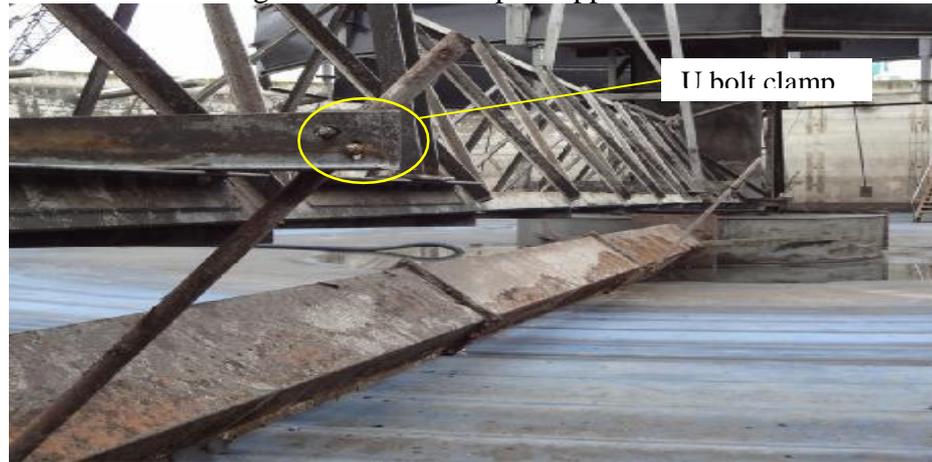
Figure 6: U-bolt scraper support

During the earthquake the pipes slipped through the U-bolts until the scrapers hit the floor. It was speculated that the same thing had probably happened on Clarifier 1. If the scraper arm itself could be attached to a chain hoist and jacked off the floor then Clarifier 2 might be able to run. Two maintenance hands in a dinghy performed this task working up to their armpits in wastewater. The scraper arms were jacked well clear of the floor and the clarifier was able to be restarted (albeit with reduced performance).

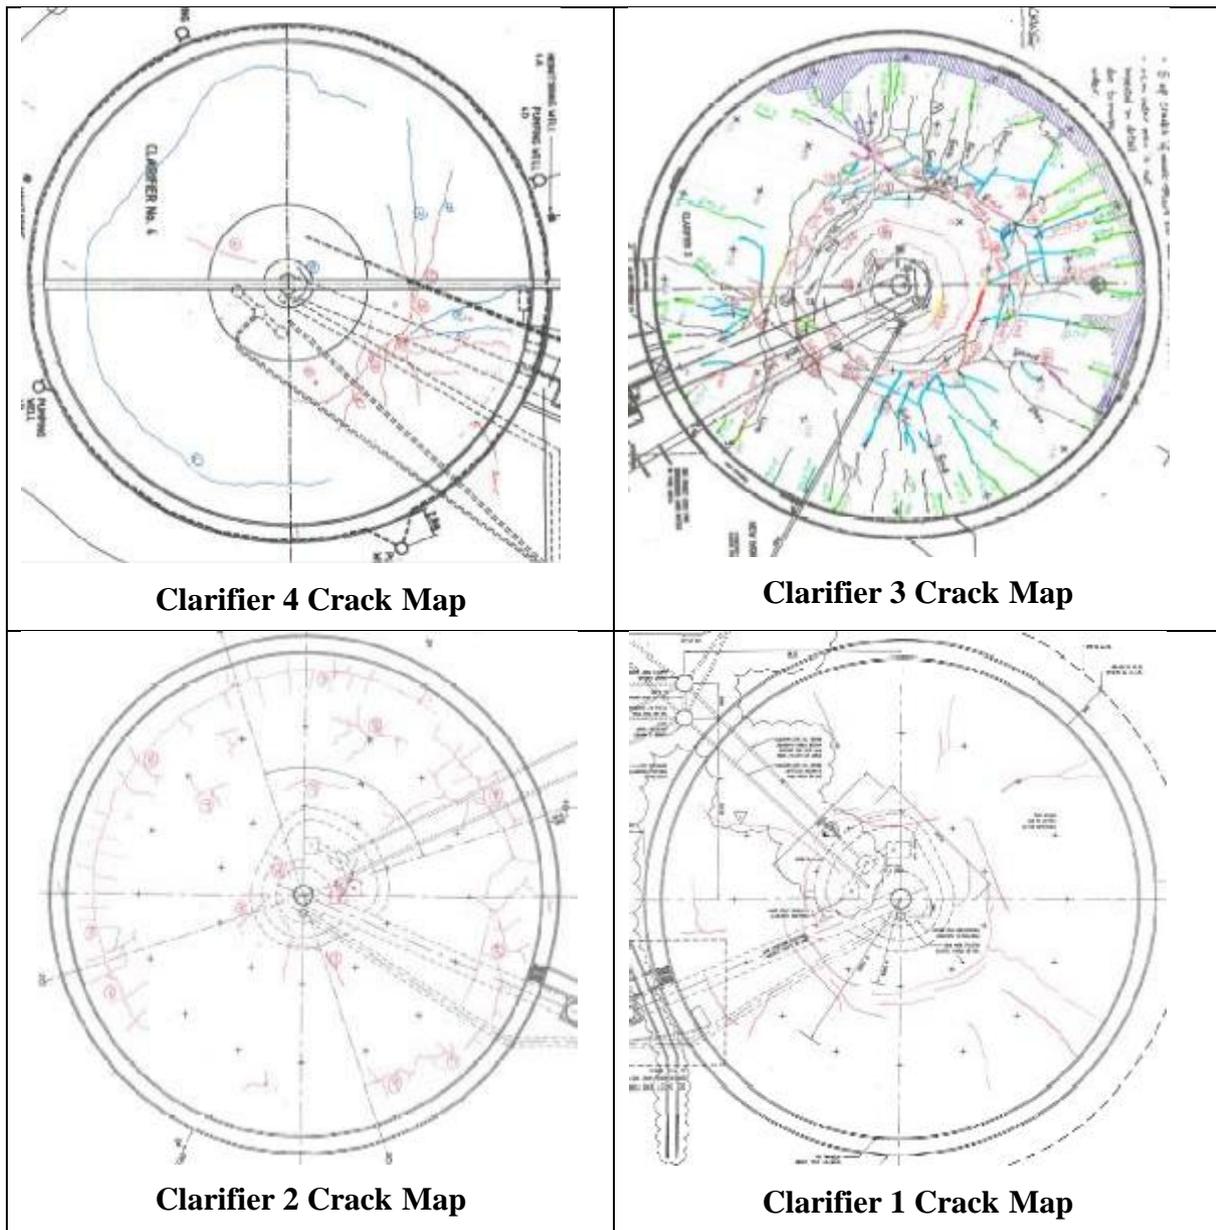
Figure 7: Clarifier Crack Maps

Clarifier 1 survey indicated that the floor suffered uplift of about 90mm and the central foundation had risen about 80mm relative to the walls. The uplift of the slab was distributed reasonably evenly in a circumferential annulus around the mid-point of the slab, with the upward deflection causing a series of circumferential cracks of up to 2mm width at the surface of the post tensioned slab, with minor radial cracking in the outer third attributable to differential settlement around the perimeter.

Clarifier 3 floor suffered considerable damage with a maximum uplift of about 600mm and widespread circumferential cracking of the floor slab – many of the cracks being several millimetres in width. The maximum uplift was also over the influent pipe. The central foundation also rose significantly – in the order of 300mm relative to the walls.

Clarifier 4 floor was subjected to uplift of up to 200mm and the central foundation rose about 100mm relative to the walls. The uplift of the slab was mostly confined to the area above the influent pipes where a pronounced local vertical deflection or “bulge” of approximately 100mm was observed. The upward deflection caused a series of cracks of up to 2.5mm width at the surface of the post tensioned slab, radiating outward from the point of maximum deflection.

Crack mapping also showed wide variation in the response of each clarifier to earthquake – imposed loads. There is no obvious rational explanation for the wide disparity in floor cracking and deformation observed. The design of all clarifiers is the same and the foundations of all four clarifiers involved use of the same ground improvement in the form of stone columns to a standard set out and depth. Hypotheses for explaining the differences in behaviour include the following:

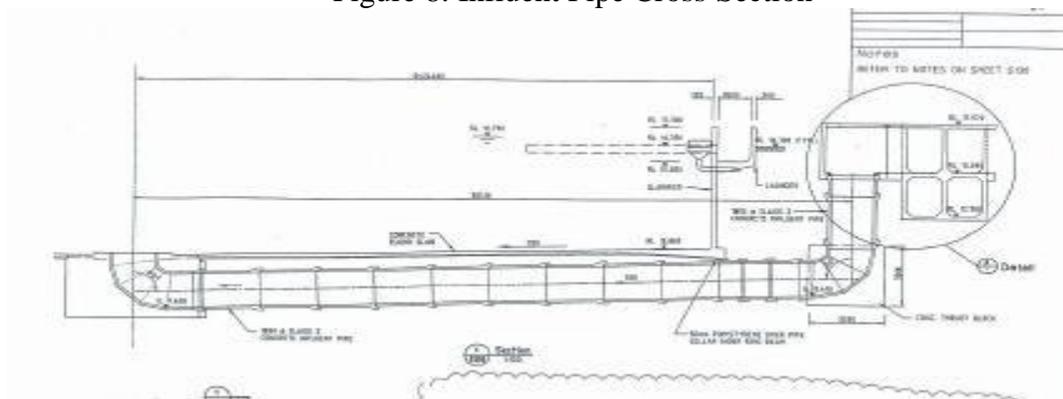
Figure 8: Influent Pipe Cross Section

Hydrostatic head testing of the influent pipes identified significant levels of leakage. A dive survey of the influent pipe on each clarifier was then conducted to ascertain joint movement and settlement. The dive surveys showed that the cumulative gap across all thirteen pipe joints had closed by as much as 120mm, with the cumulative gap along the bottom of the pipes typically less than across the top. The dive inspection also found evidence of spalling at the pipe joints indicating impact damage between the pipe sections.

This simple analysis indicated likely ground movement around the pipe causing shortening with the attendant risk that subsequent seismic events could cause further movement and damage. Any repair solution needed to be capable of accommodating a similar amount of movement – i.e. another 120mm, while retaining the integrity of the repair. Further minor shortening could take place to the point where all joints are closed, but equally, a future event could lead to extension of the pipe. This was an important consideration in the selection of the repair method.

Having taken consideration of the above options it was concluded that the CIPP system installed with a vinyl ester resin binder offered the optimum solution to repair the leaking joints and provide resistance against future seismic events. The CIPP liner system results in what is effectively a new pipe formed inside the existing pipe by using a polyester fabric impregnated with thermo setting resin inflated against the existing pipe and cured with hot water or steam. The thickness of the newly formed pipe was designed to suit loading conditions.

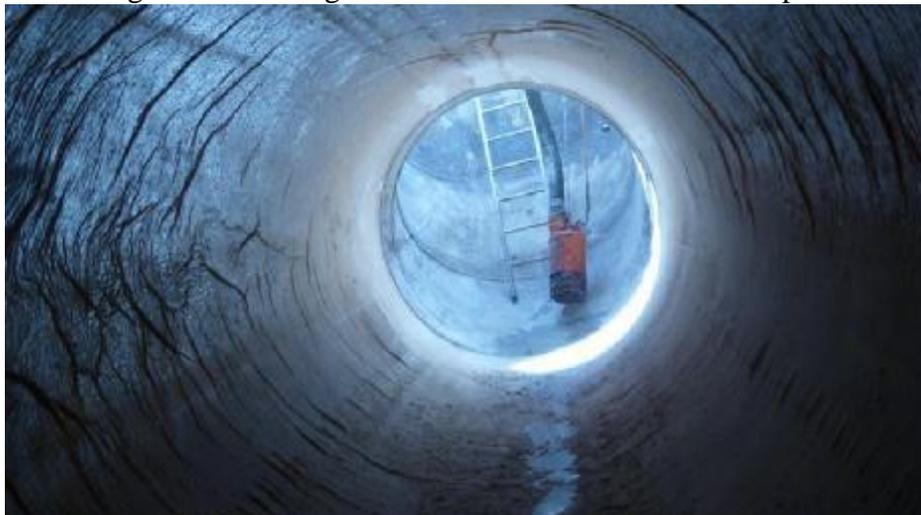
Figure 9: Creasing of Liner on Clarifier 4 Influent Pipe

One potential problem with a very thick CIPP liner is that it will not accommodate the sharp bends in the pipe if the liner is installed as a single length. The proposed approach to overcoming this problem on the inlet pipe involved installation of several liner sections including once section with custom made fitted CIPP bend piece. However during the construction phase it was found that a single straight liner was able to fit around the 90 Deg bend with a minimum amount of creasing and this was the finally adopted solution. Some creasing was identified on the straight section of the finished liner on Clarifier 4 and this occurred because the liner ID did not exactly match the pipe ID (refer to Figure 9.). This problem was corrected for the liners on Clarifiers 3 and 1.

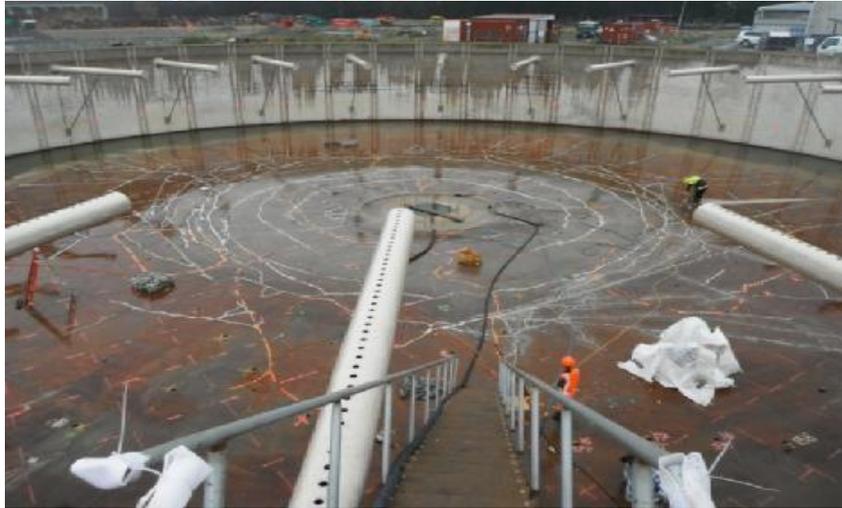
Figure 11: Inverted floor cone on Clarifier 3

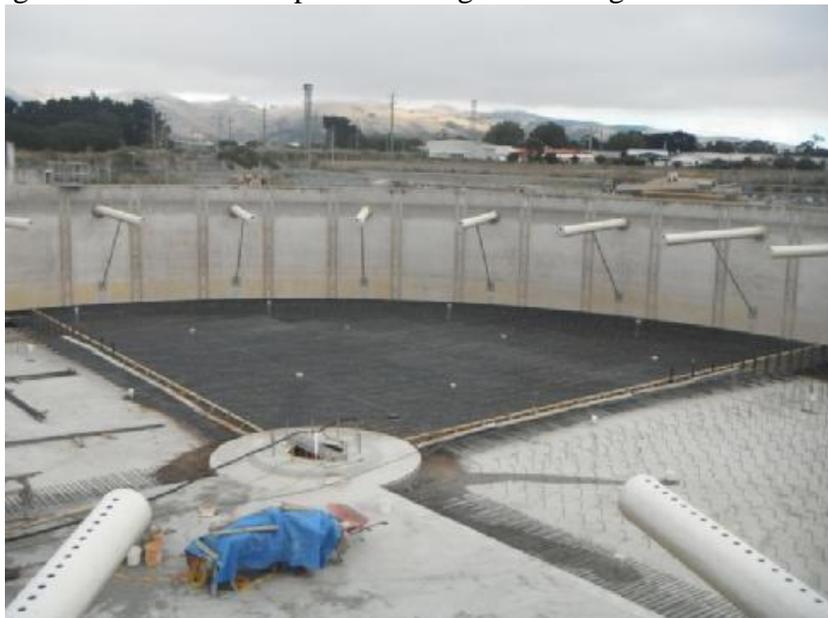
Figure 12: Clarifier 3 repairs showing reinforcing mats

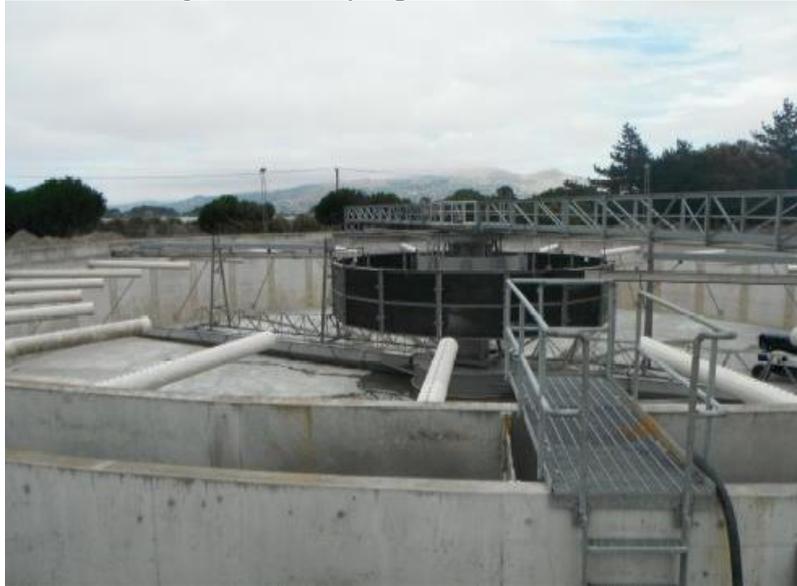
Figure 13: Fully repaired Clarifier 4
