GIS Application in Technical and Environmental Safety of Natural Gas Transmission Pipelines, a Case Study

Tuncer OZERBIL, Engin PEKEL, Dilvin Cenedi TUGRUL, Cihan SEZGIN and Osman SELCUK, Turkey

FIG Congress 2018

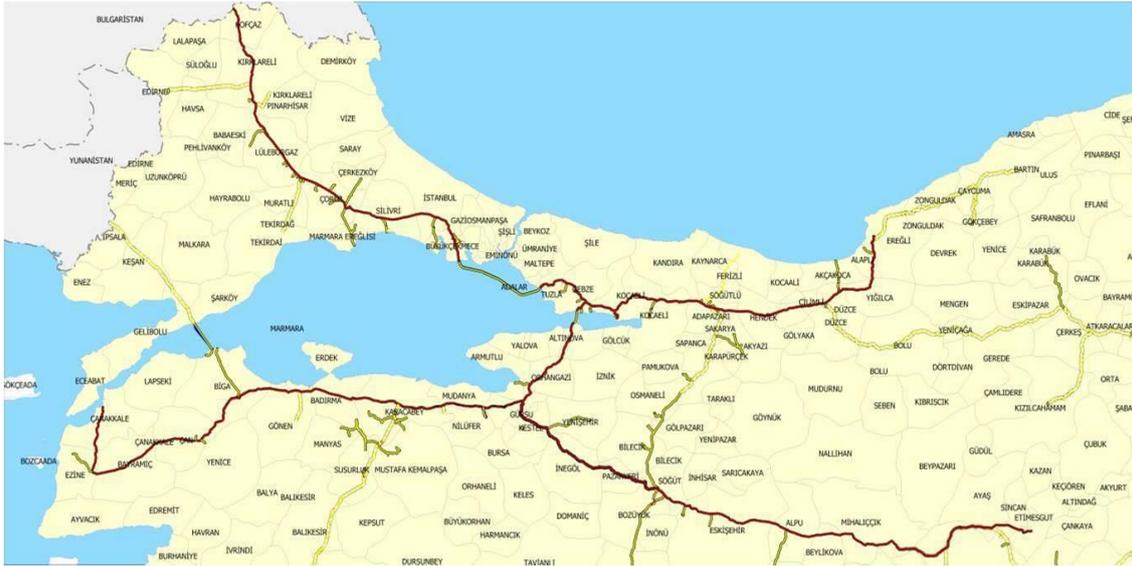
Figure 2

The scope of Project in general consists of two stages. First is route control for anomalies by air vehicles along 1203 km long pipeline in 400 m wide, including stations settled on the route (Figure 2). The second is natural gas leak inspection by air vehicles inside at least 7 m wide corridor (3.5 m wide at left and right side of center line of pipeline).

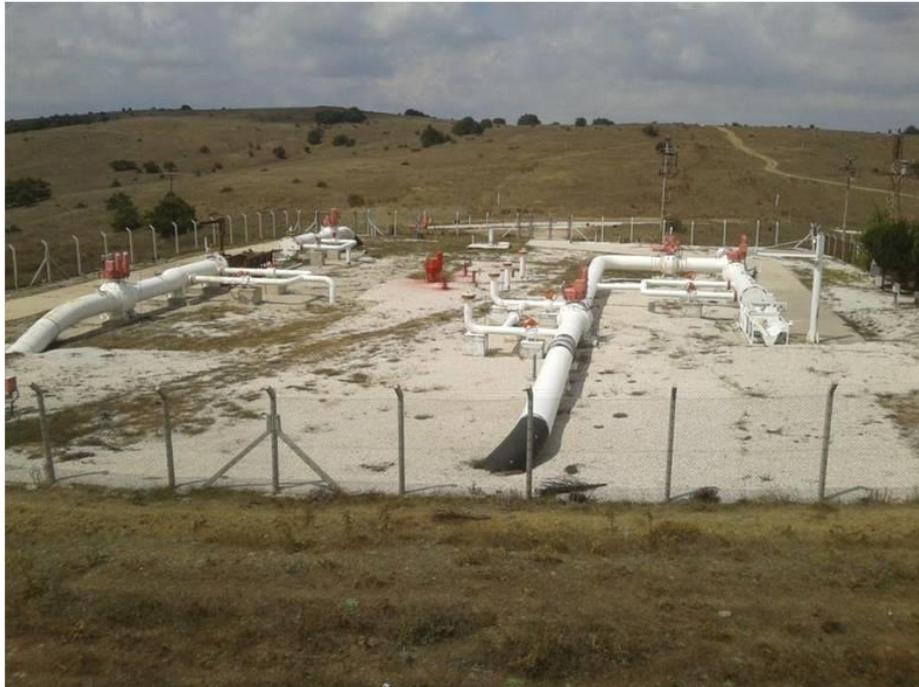
Figure 3

- Line Vanes Stations,
- Pig Stations (Figure 3),
- Regulator / Meter Stations (RMS),
- Compressor Stations,
- Take-off Vane Stations.

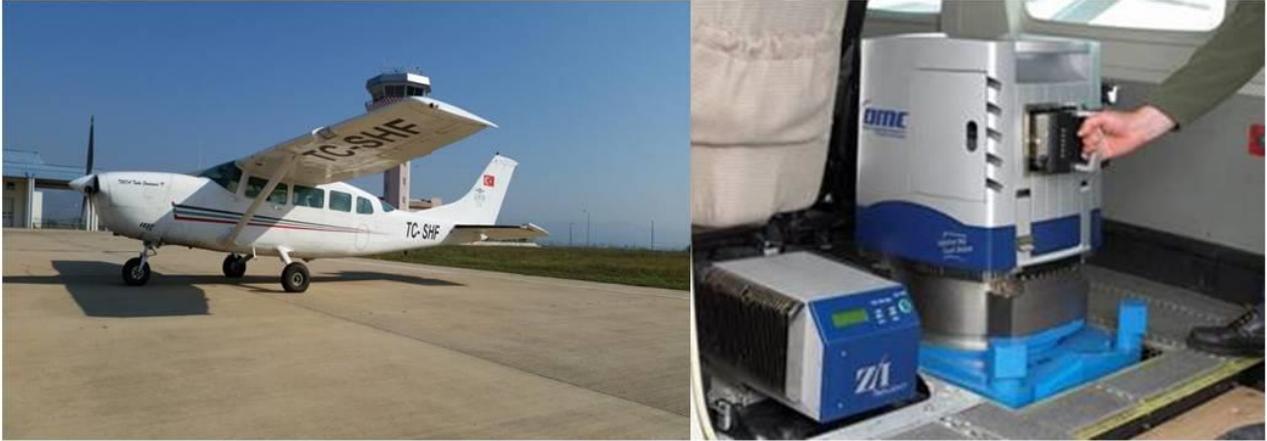
Figure 4

For aerial photo acquisition, Cessna T207A model aircraft and Intergraph DMC camera of GEOSIS were used (Figure 4). After the photogrammetric triangulation and adjustment process, the photographs were made ready for photogrammetric interpretation.

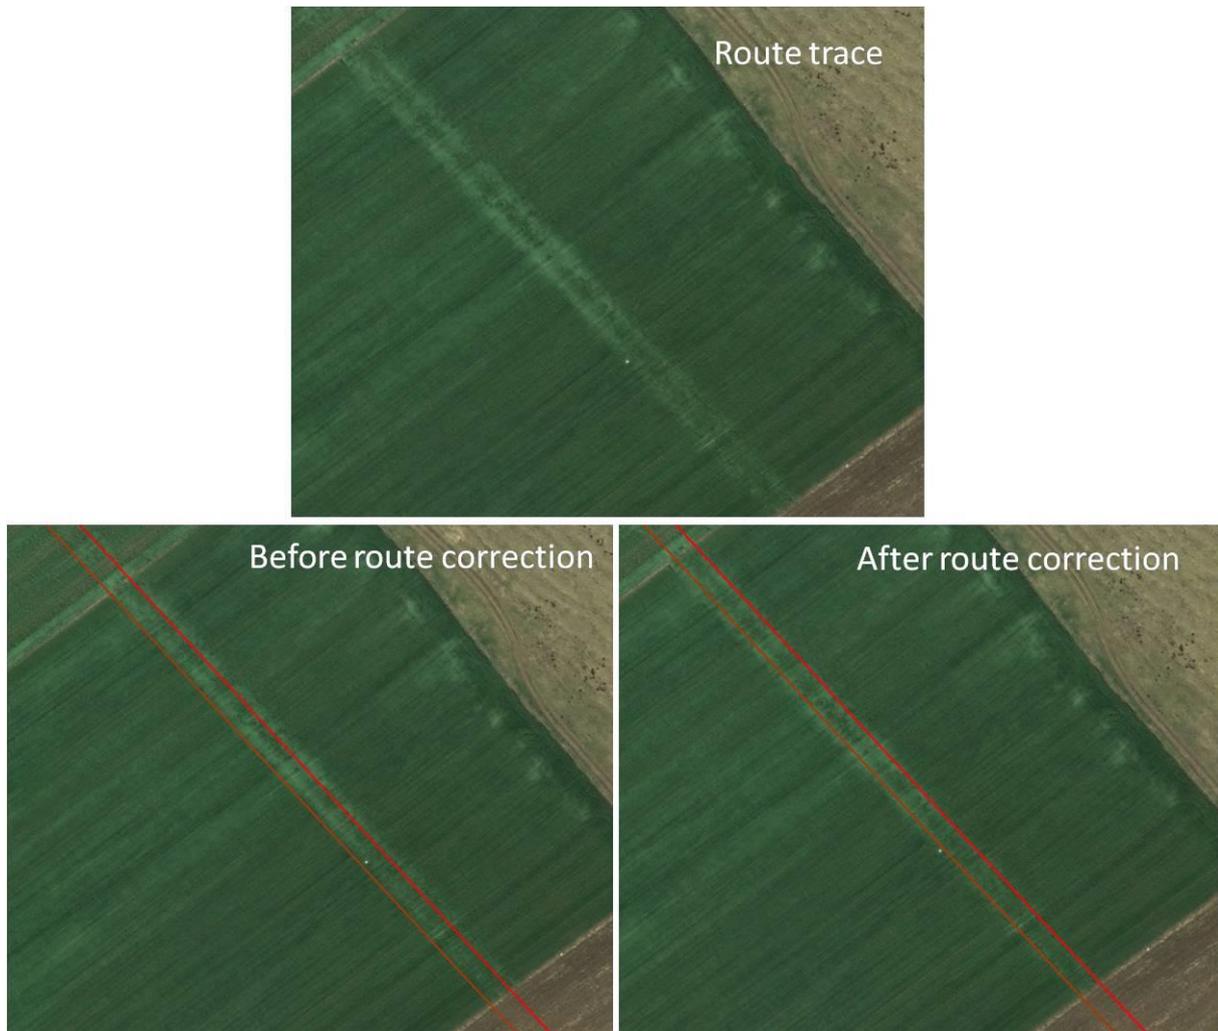
Figure 5

The pipeline route was visually controlled via aerial photographs and corrected by using evident traces and line markers that are on the pipeline (Figure 5).

Technical support was obtained from BOTAŞ experts during this process. The amount of correction is in the range of 1,5-2,5 m and it is observed during the verification tests made on the field, the attitude accuracy of pipeline is in the range of 5-20 cm after correction.

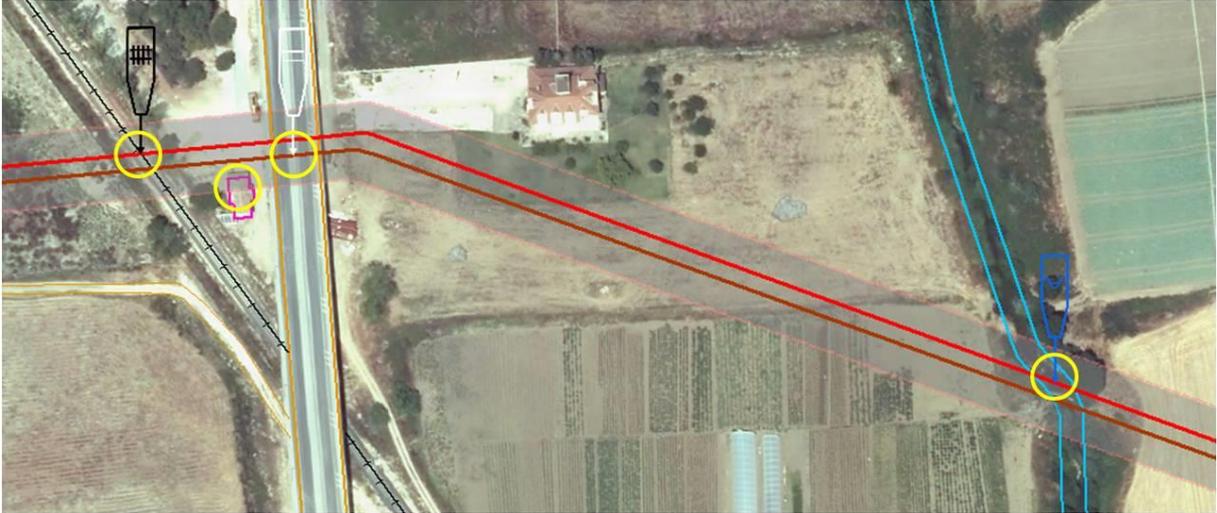
Figure 6

After the location-accurate pipeline data was obtained, location analysis was performed using this data and other geographical data so that anomaly data sets for the crossing points were obtained. Furthermore, after buffer analysis, buildings close to the pipeline route were added to the anomaly data set (Figure 6).

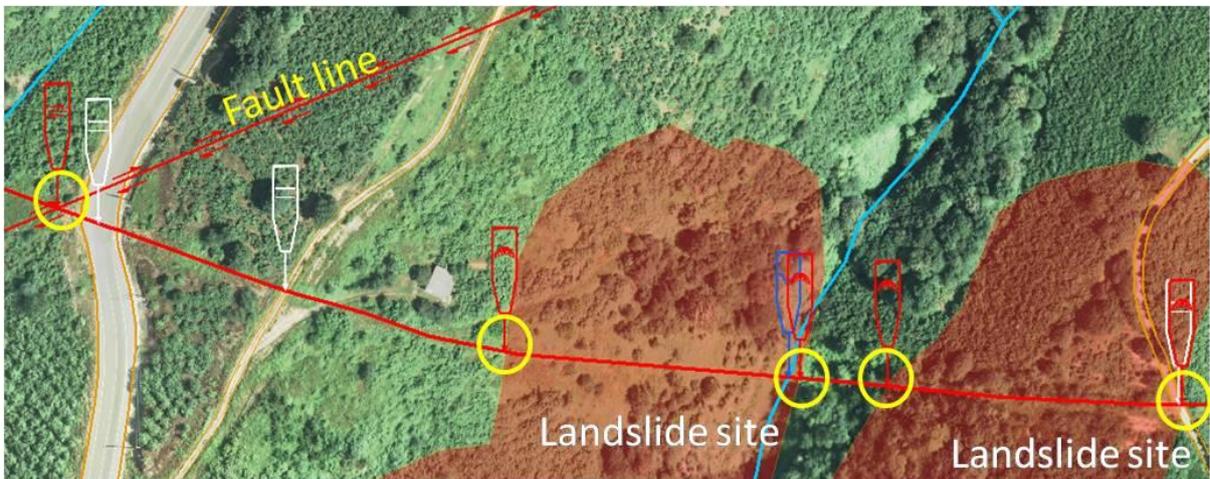
Figure 7

Points where the landslide and erosion areas cut into the pipe line or the points on the pipeline that are close to those zones are also part of the data set as geological anomalies. The fault lines and the points at which fault lines cut into the pipeline are also elements of the data set (Figure 7).

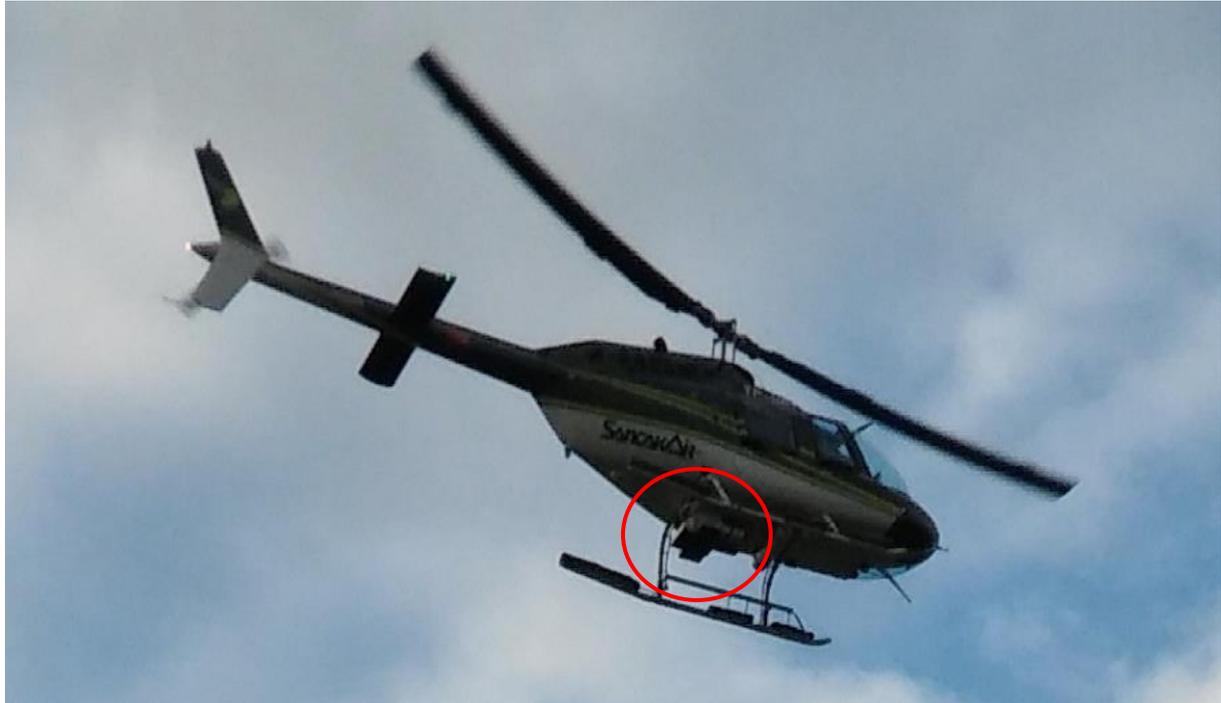
Figure 10

As the detector, ALMA G2 (Airborne Laser Methane Assessment) optical device mounted on a Bell 206 Jet Ranger helicopter was used (Figure 10).
