Earthquake Repairs at Christchurch WWTP – Clarifying the Situation

Greg OFFER, Ian BILLINGS, Tim SCOTT, New Zealand

Key words: Secondary Clarifiers, Earthquake Repairs, Resilience, CIPP Liners

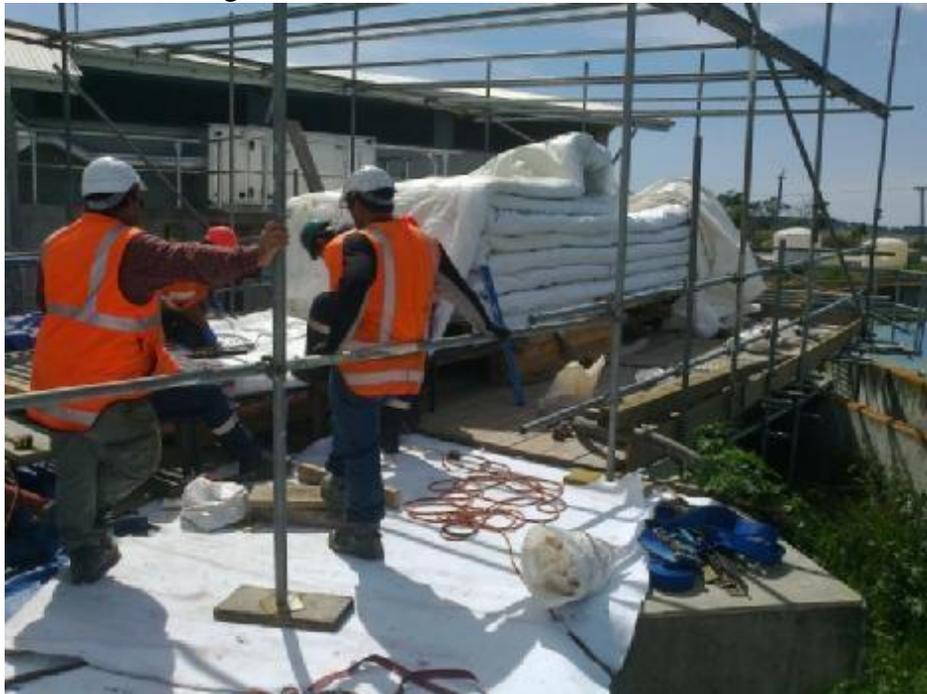
Figure 10: CIPP Liner Prior to Installation

The pipe repair works were let as a separate package and the contract was awarded to Pipeworks Ltd. The pipe repairs were timed to work in with the structural and mechanical repairs to the clarifiers. Pipeworks mobilised to site for each repair which was typically completed over a two week period. The 1800 diameter CIPP liners installed on the CWTP clarifiers are the largest CIPP liner installed to date in New Zealand. Figure 10 shows the contractor team unravelling the liner prior to installation.
